ASBESTOS SURVEY REPORT

1230 12th Street Avenue, Modesto, CA 95353

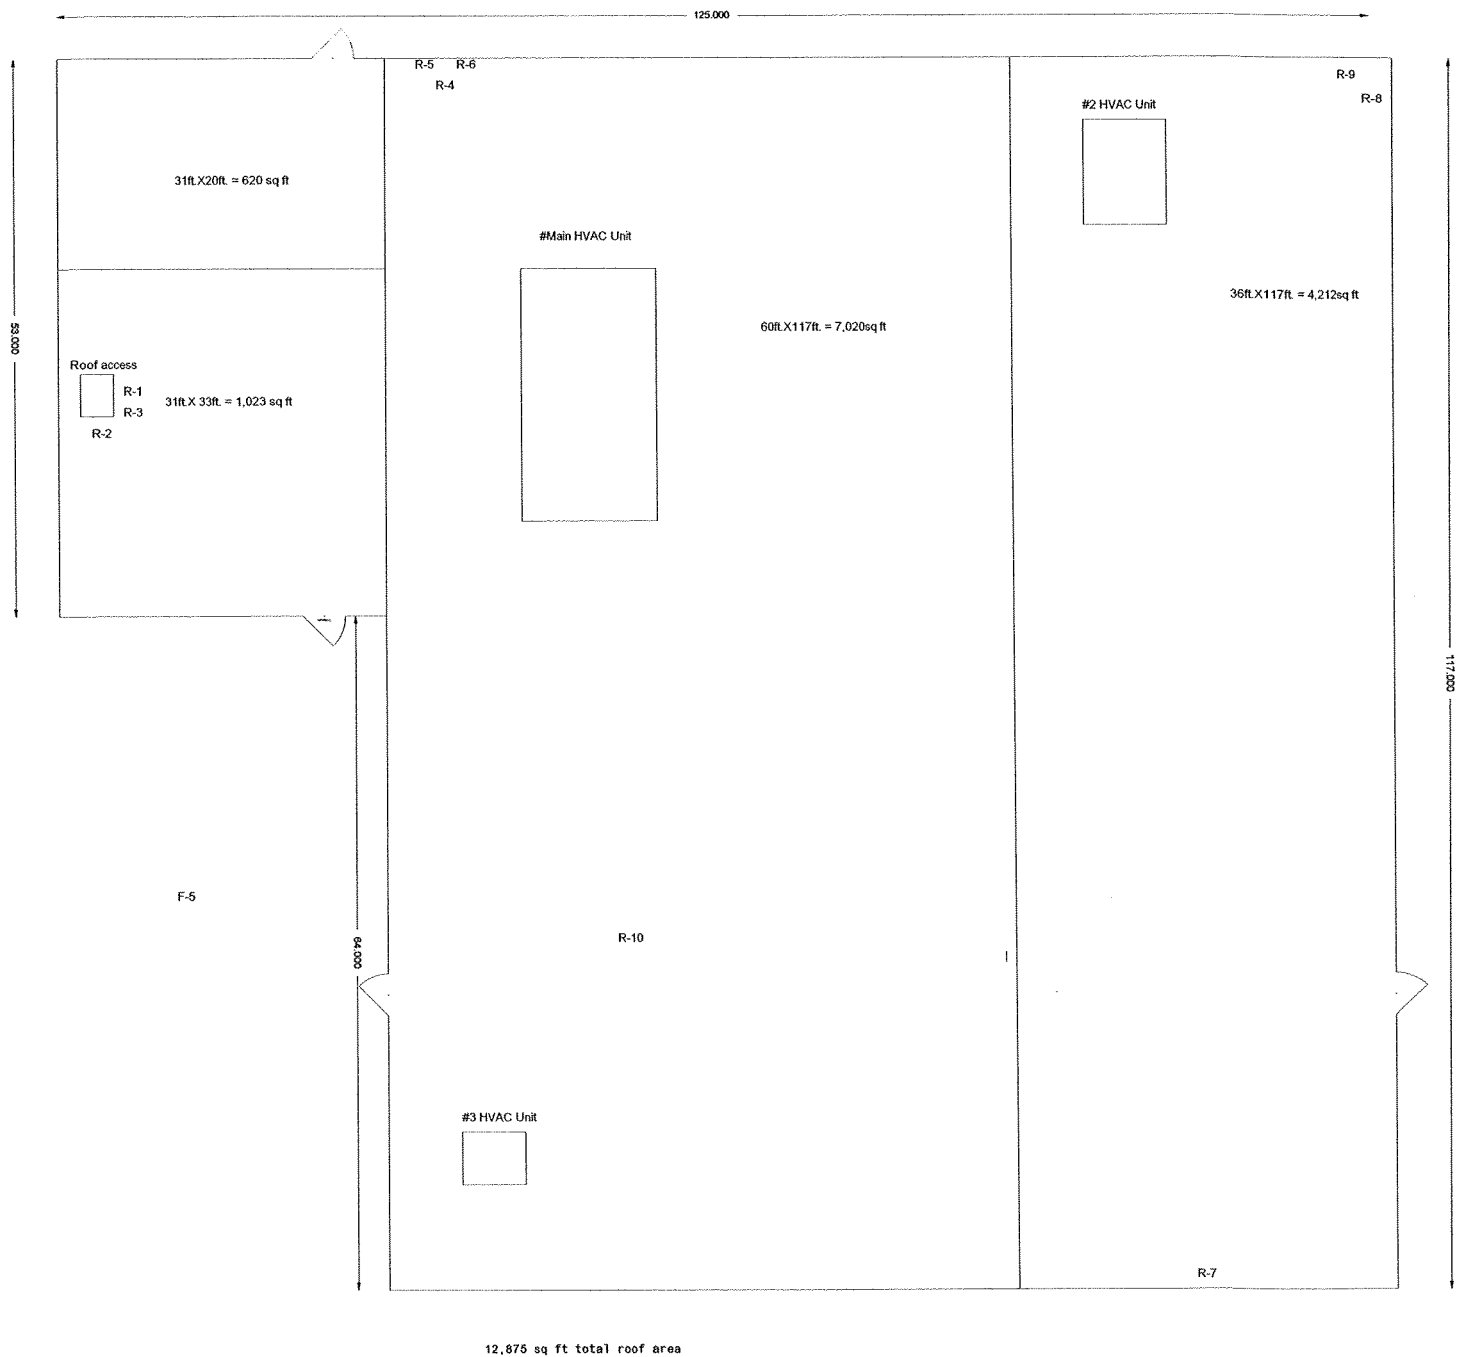
Asbestos Test Locations- Roof

Testing Samples R-2 Roof Mastic (Black) at 2% Chrysotile and R-9 Roof Mastic (Black) at 5% Chrysotile.

Testing Sample R-2 – Roof mastic is less than 3 square feet in quantity and R-9 –Roof mastic is less than 5 square feet. in quantity.

The material in testing samples R-2 and R-9 are Category II non-friable ACBM, non homogeneous in nature due to the structure being built in two phases. The amount asbestos in the mastic on samples R-1 and R-2 is less than 100 sq ft., according to NESHAP this is a non- regulated material.
